Pecos, New Mexico USA Lead-Zinc Mill Tailings Site: Case Study of a Durable Solution to an Inactive Mine Waste Pollution Problem

Environmental Remediation and Mine Waste Management Seminar Bucharest, Romania April 21-23, 2004

A Case Study with application for environmental remediation in Romania - the Pecos lead-zinc tailings sites, New Mexico.

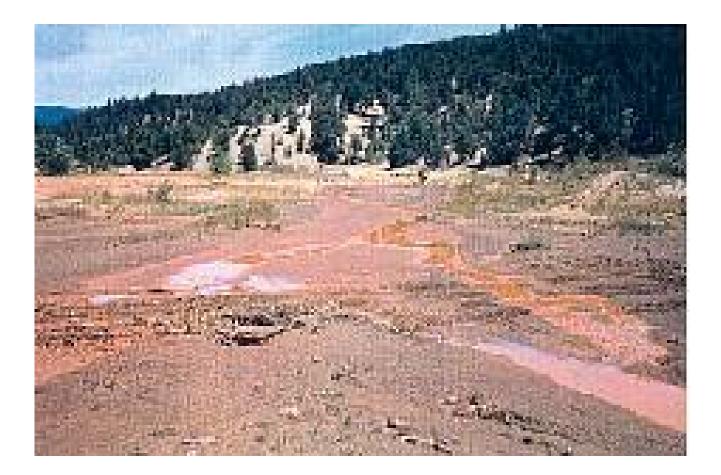
Acid drainage at Pecos tailings site before remediation

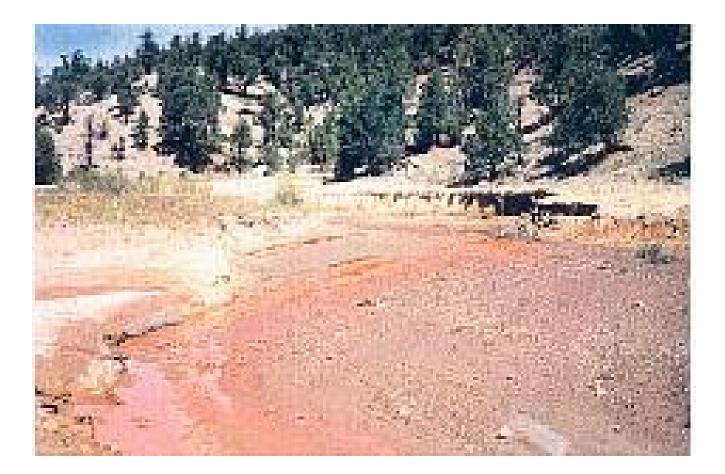
Active stream cutting causing erosion into tailings before remediation

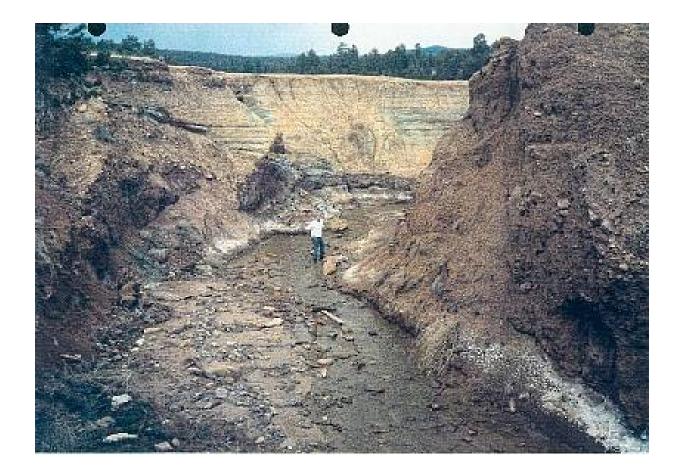
Severity of erosion into tailings before remediation
